THESIS FOR THE DEGREE OF DOCTOR OF PHILOSOPHY

Natural corrosion in reinforced concrete structures

SAMANTA ROBUSCHI

CHALMERS
UNIVERSITY OF TECHNOLOGY

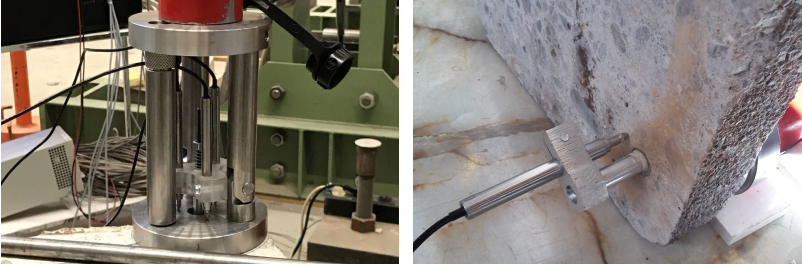
Figure 3.9: Photographs of pull-out rig and slip measurement devices. Note that specimen to the right is tilted with respect to normal testing position to better show the measurement device.
